**OFFICE OF THE SPECIAL INSPECTOR GENERAL
FOR AFGHANISTAN RECONSTRUCTION**

**INSPECTION OF FARUKH SHAH SCHOOL CONSTRUCTION
PROJECT IN KAPISA PROVINCE:**

**PROJECT COMPLETION APPROVED BEFORE ALL
CONTRACT REQUIREMENTS MET**

October 26, 2009

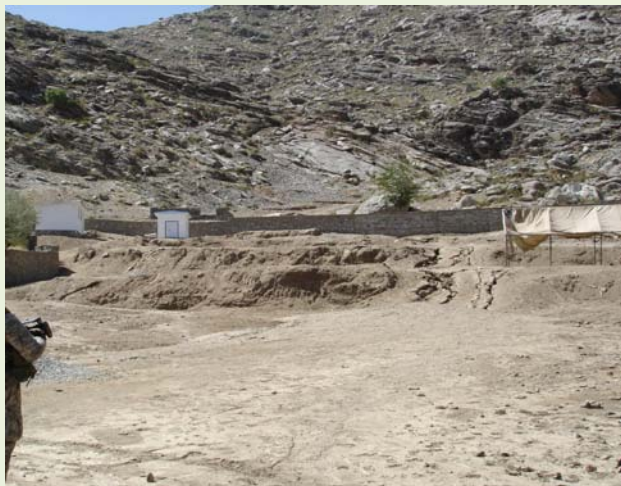
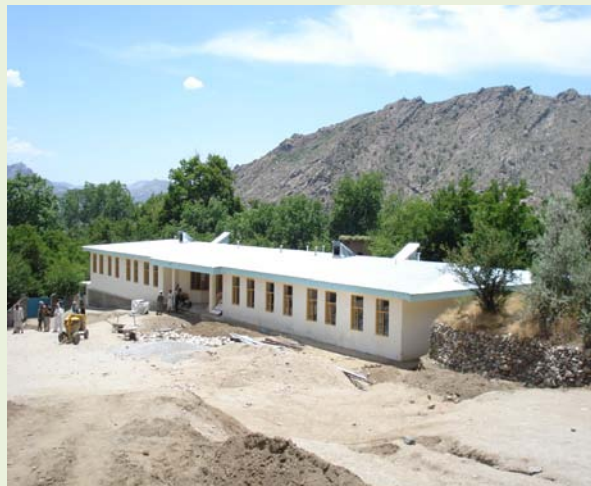
- *Design Deficiencies:* SIGAR also found two project flaws that could affect the long-term viability of the school infrastructure. Improper grading, including a lack of terracing to mitigate the effects of soil erosion, and the absence of a retaining wall increases the risk that landslides will eventually damage structures on the school compound. SIGAR believes both these items should have been anticipated and included in the project's scope of work.

Views of the rear portion of the perimeter wall which is inadequate to protect the Farukh Shah School compound from rock slides on left, and improper grading on right that places the school compound at risk. (Photos provided by SIGAR).

- Issue a follow-up contract to address the construction deficiencies noted in this report.
- Place greater emphasis on developing detailed scopes of work which anticipate and address critical design issues that are particular to each construction project rather than relying solely on standard design plans.

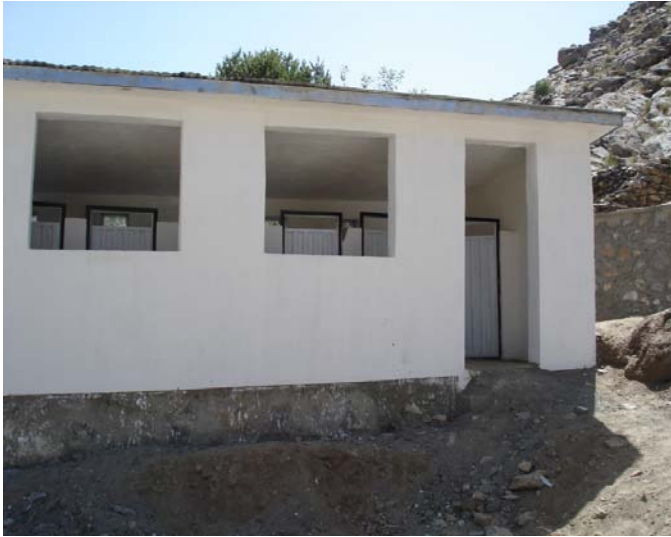
During our June inspection visit, SIGAR observed portions of the latrine concrete walls that were severely cracked and a defective roof that allowed wind and moisture to enter the structure that had to be removed. SIGAR also observed refuse removal openings in the rear base of the latrine structure that

were too small to adequately remove the human waste that will accumulate in these locations. During SIGAR's follow-up site visit in August, we found that although some improvements were made to the latrine building, including the installation of the new roof, other deficiencies, such as the inadequately sized openings for refuse removal, remained.

Site photo 2: View of the latrine containing inadequate opening sizes for refuse removal. (Photo provided by SIGAR)

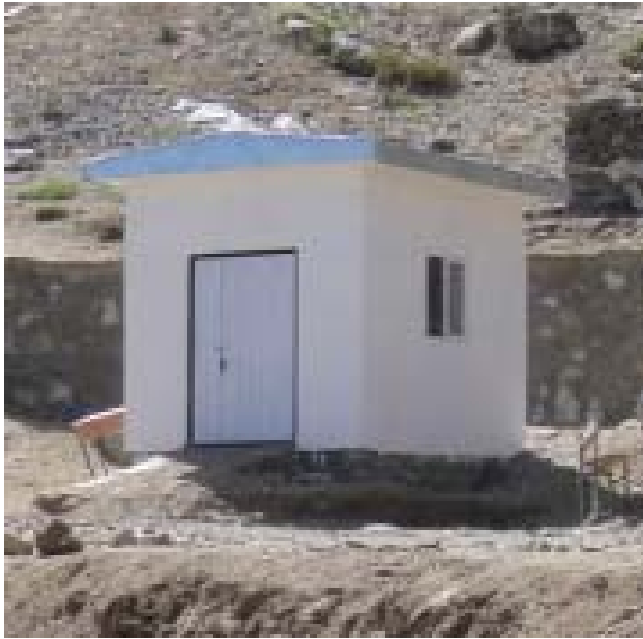
SIGAR found that the power plant building was adequately built following the replacement of the original roof that had to be removed due to defective construction methods we identified in June 2009. Additionally, during the August onsite visit the SIGAR inspection team had the opportunity to examine the 10 kilowatt generator. SIGAR found that the generator had not been permanently installed. No venting pipes or vent openings were installed, as required by the statement of work, to properly allow vent fumes produced during generator operations to escape the building. Additionally, the building lacked a concrete walkway and no fuel tank was installed at the time of SIGAR's June inspection. During the August onsite visit SIGAR noted that although some improvements were made, such as a newly installed roof, several items required by the statement of work had yet to be accomplished. These items include venting pipes for generator exhaust and concrete walkways leading to the school. During

SIGAR's second site visit, we also learned that no individual had been designated or trained to serve as the generator operator and electrician to handle power issues for the school.

Site Photo 3: View of generator house which lacks proper exhaust venting as required in the statement of work. (Photo provided by SIGAR)

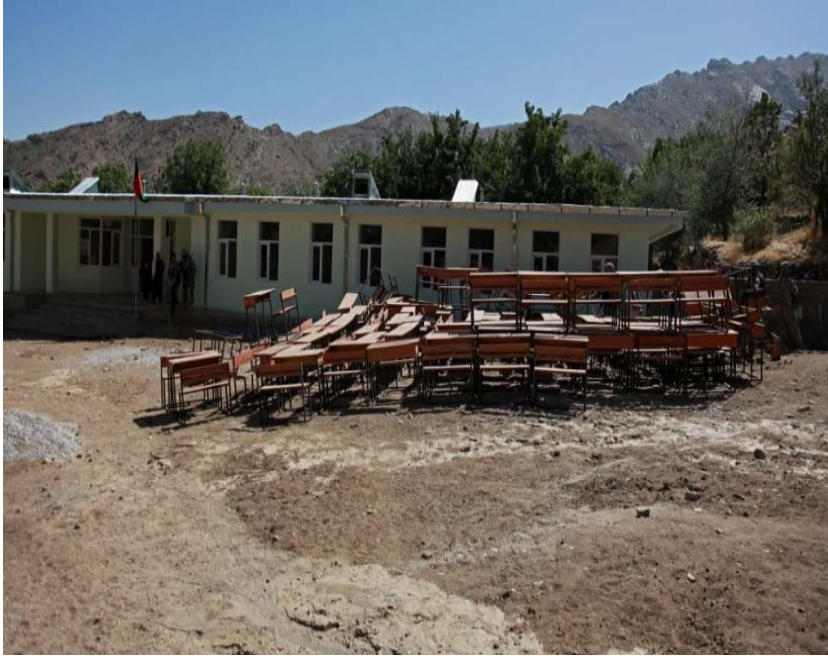
SIGAR noted that the school compound had not been adequately cleared of debris and rubbish left over from construction activities. Additionally, old student desks that were apparently not needed by the school administration were placed in two large piles on either end of the school. It is unclear when or if these materials will be removed.

Site photo 5: View of discarded old school desks outside of the main school building. (Photo provided by SIGAR).

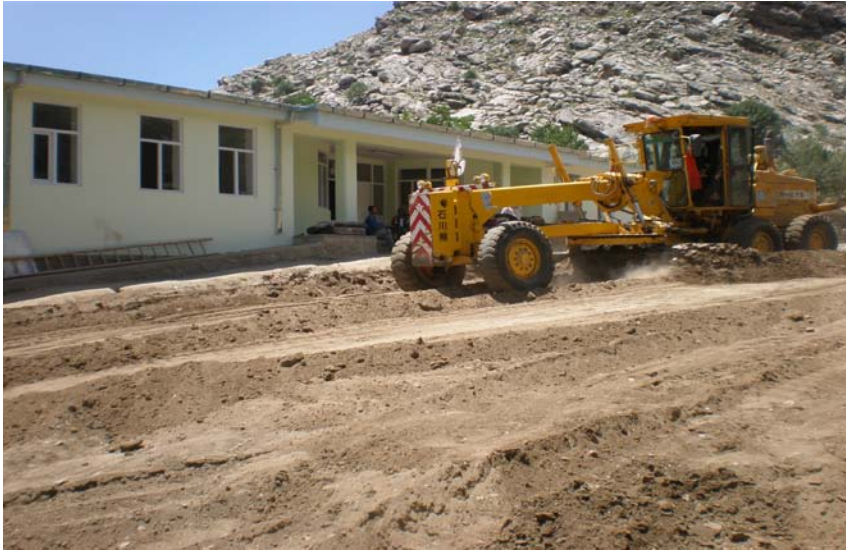
SIGAR found two serious project design flaws. First, instead of properly grading the site and compacting the construction site's soil, the excavated material was placed in the lower portion of the school grounds. This area is subject to severe erosion which creates a potential threat to the integrity of the various buildings on the school grounds (see Site Photos 6 and 7).² SIGAR believes that the absence of adequate earthwork provisions in the contract's scope of work led to this condition. The only practical solution to this serious design problem is to conduct another topographic survey and develop an effective grading plan that will prevent erosion from undermining the foundations of the various structures on the site. SIGAR noted in discussions with PRT and school officials that there is interest in developing a plan that can best utilize the newly leveled land for other purposes such as a soccer pitch and play ground.

Site Photo 6: View of grader attempting to level the ground in front of the school house in mid- July. This grading improved, but did not solve, the ground erosion problem because there was no follow-up compaction of the soil. (Photo provided by Kapisa PRT)

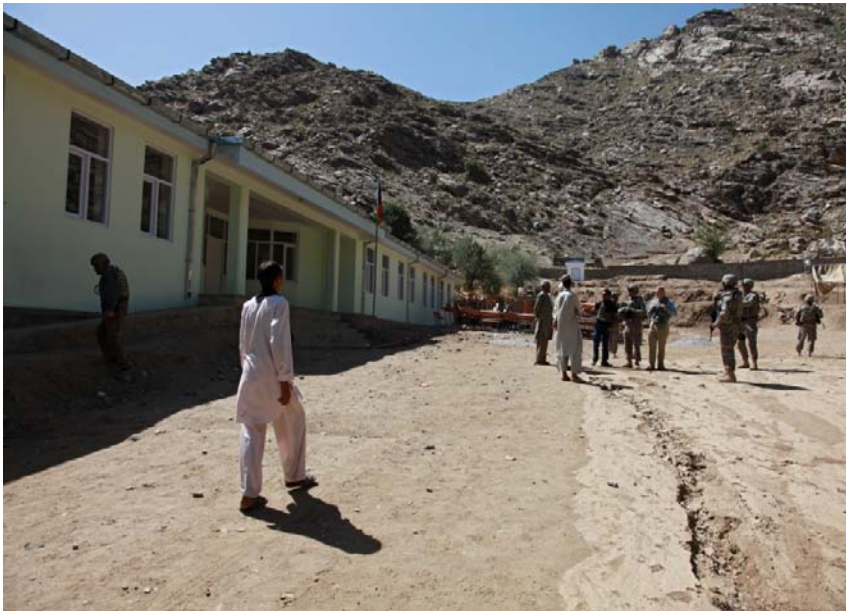
Site Photo 7: View of school grounds less than one month after grading work was completed showing signs of site erosion. (Photo provided by Kapisa PRT)

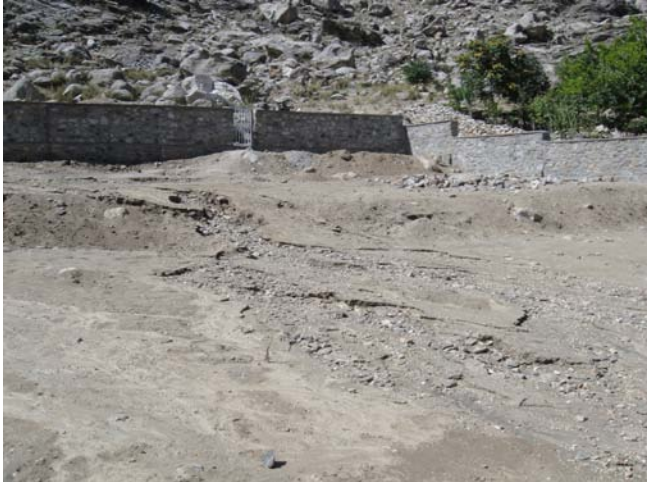
Second, SIGAR also found that although the perimeter wall appeared to be solidly built and in accordance with the statement of work, it mostly serves as a retaining wall due to the nature of the school grounds topography. SIGAR notes this is potentially dangerous since the perimeter wall was not built to retaining wall standards which require a much larger and stronger foundation base. Given the nature of the area's topography with evidence of recent rockslides and erosion, the possibility exists that areas of the perimeter wall may suffer washout and collapse unless it is further reinforced. (See Site Photos 7 and 8).

Site Photo 8: View of 2 meter high stone masonry perimeter wall at the rear of the school compound. The significant level of erosion can be seen. The perimeter wall parallel to the slope can be seen on the right. (Photo provided by SIGAR)

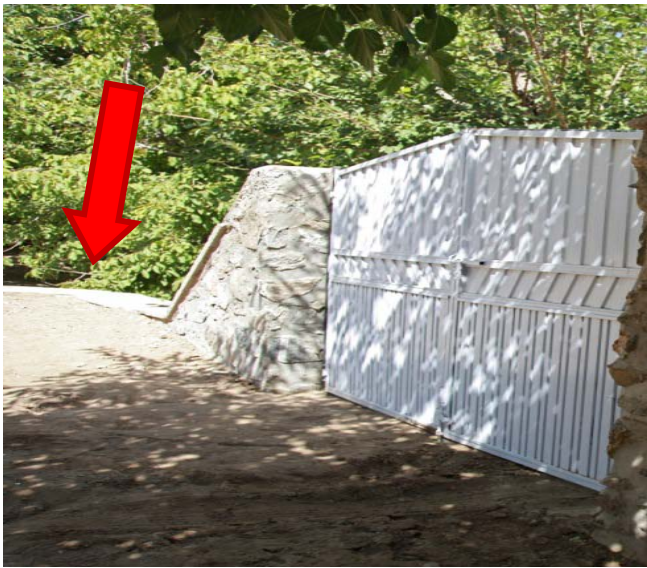
Site Photo 9: The top of the 2 meter perimeter wall can be seen (indicated by red arrow). During the site grading, soil was placed against the perimeter wall, bringing the grade elevation up to the top of the wall in some areas. (Photo provided by SIGAR)
